ADDENDUM NO. 2

SUBJECT: DPW PROJECT NO. 23882
State of Idaho Deferred Maintenance Program
University of Idaho; Moscow, ID

College of Law Slab Settlement Study

FACILITIES SERVICES COMPLEX EXTERIOR EVALUATION UNIVERSITY OF IDAHO MOSCOW, IDAHO

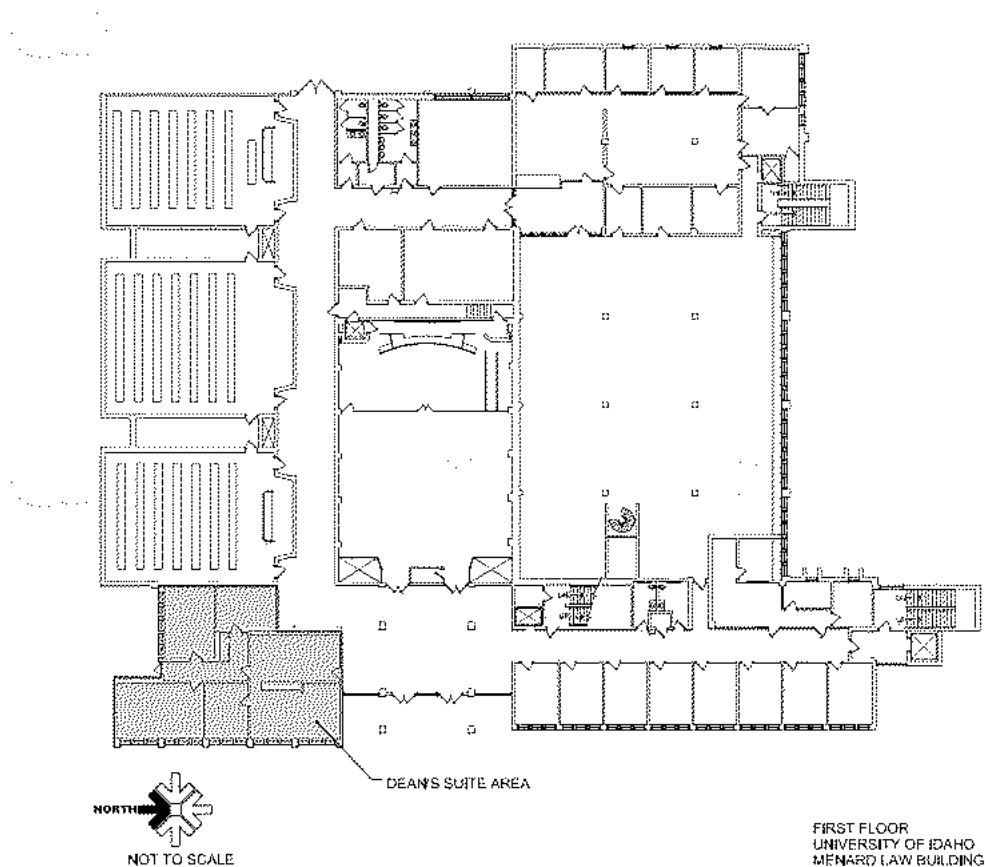
Menard Law Building key plan denoting the settlement area in the Dean's suite.

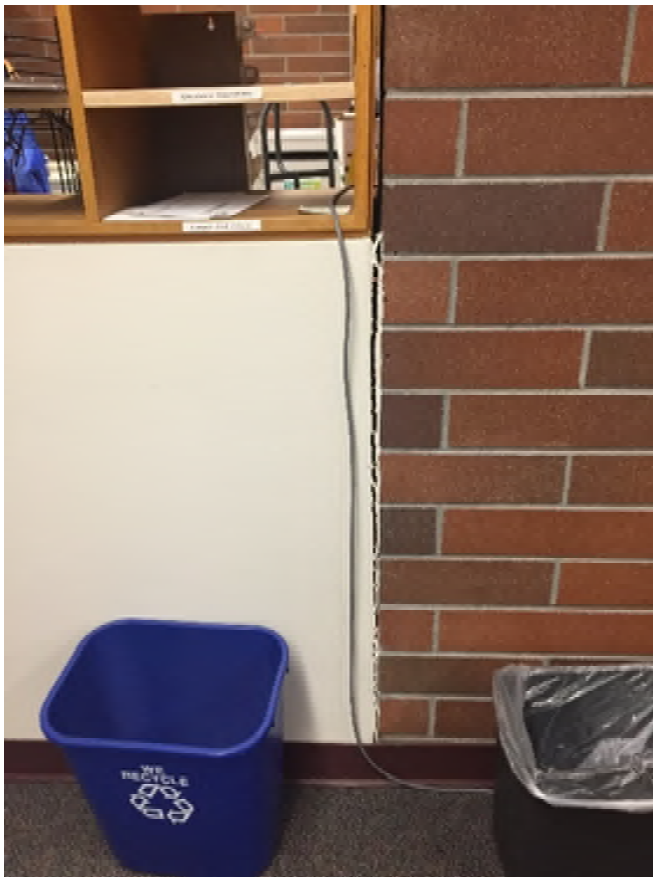
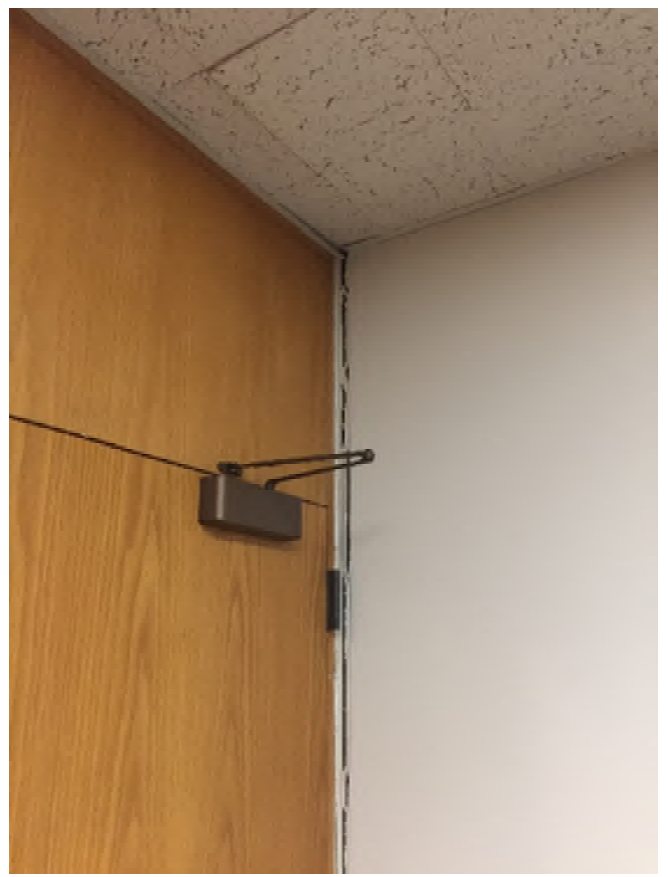
Wall pulling away from brick and typical wall separation due to concrete slab deflection.

2. Cut out and remove the areas of concrete slabs that have deflected to unacceptable grade levels. To efficiently and effectively perform this work, it is recommended that settled and damaged walls in the affected areas be removed and reconstructed over new concrete slabs. The concrete slab areas with acceptable grades/elevations to remain and areas to be removed would need to be verified and clearly demarcated.

6. In addition to removing select walls, it is recommended to remove the existing spline/tile ceiling system and provide a new suspended acoustical tile ceiling system at the same elevation. The existing spline system is damaged where walls have settled and the splined tiles make maintenance access above the ceiling difficult. A new suspended acoustical tile system would facilitate the installation of the new HVAC ductwork and related ceiling grilles and diffusers and make above ceiling maintenance more accessible.

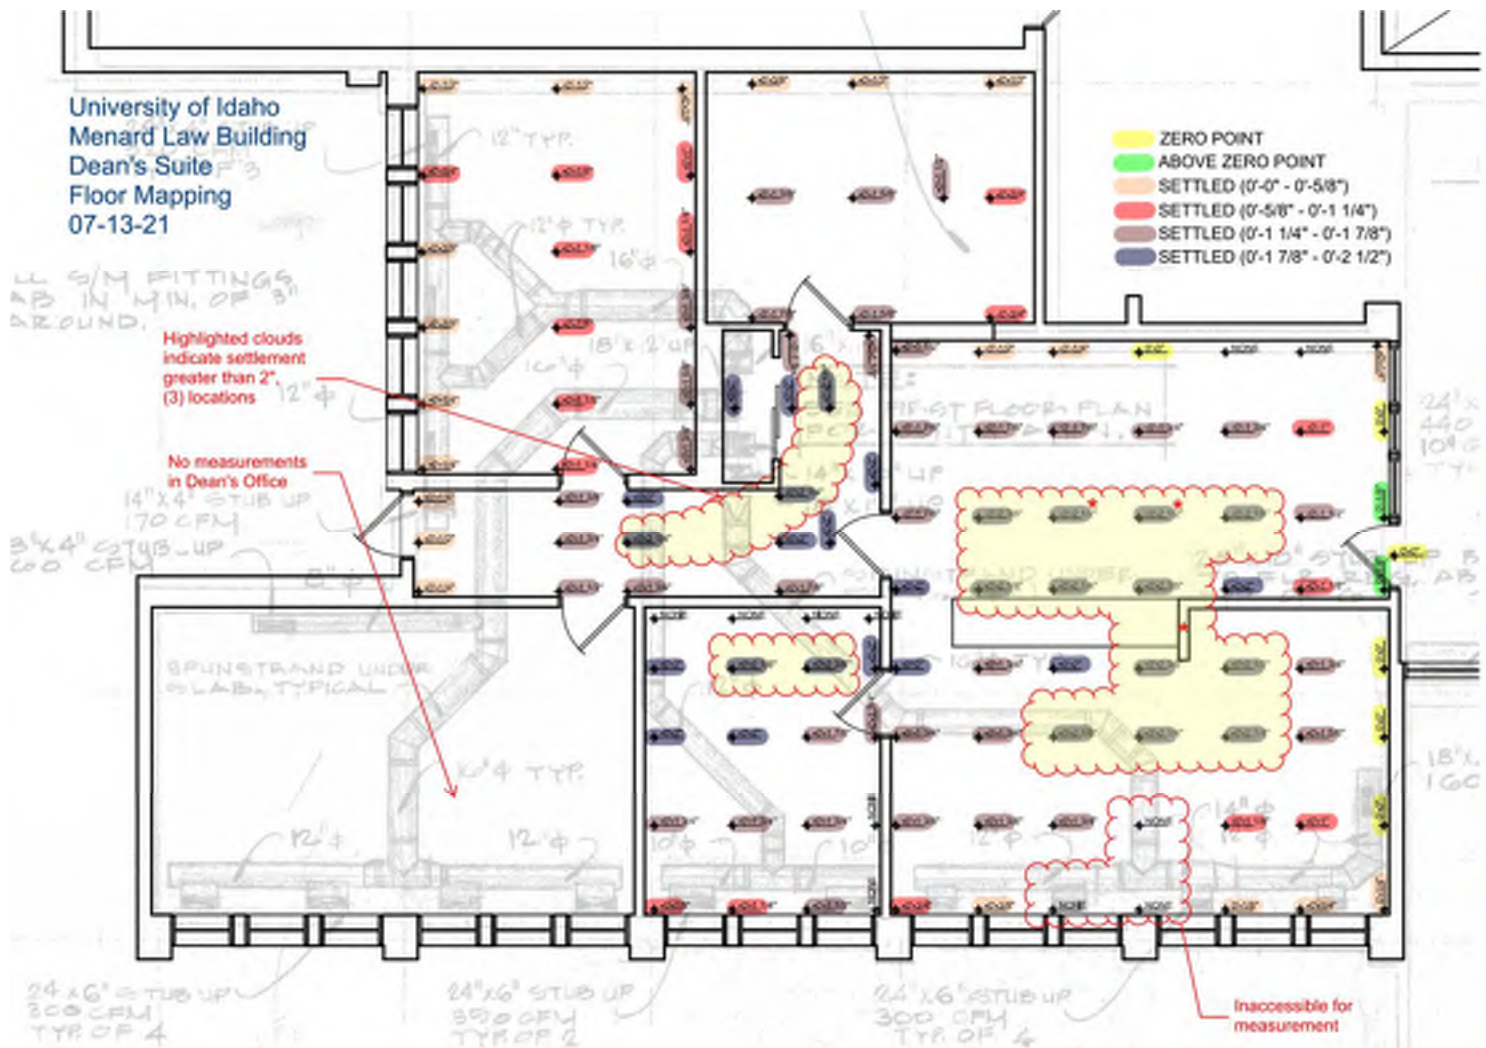
It was decided at a meeting on June 3rd to map the affected areas of deflection before performing the second investigation so the soil sample could be taken near the point of greatest slab deflection. Design West Architects completed the map below showing deflection point elevations. The map below was overlaid on the ductwork drawings provided by the university (note: the ductwork layout is schematic from the original drawings and not necessarily the as-built condition from the actual 1970s construction). No measurements were able to be taken in the Dean's office at the time of mapping the area.

5. Provide new concrete slabs in the areas where deflected slabs are removed. These slabs should be 4" thick and reinforced to bridge any residual discrepancies in the subsurface conditions and support heavier point loads. The new concrete slabs would be doweled into the existing, adjacent concrete slabs to remain.

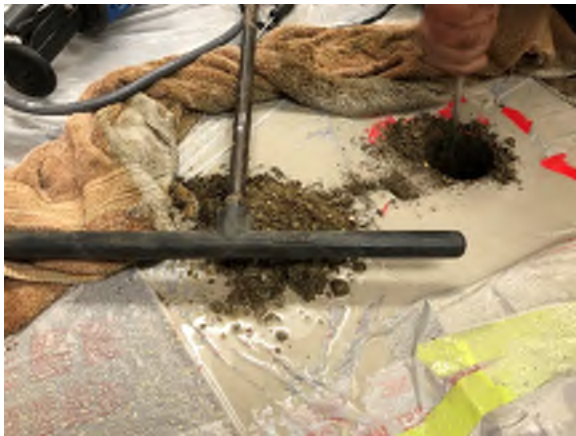
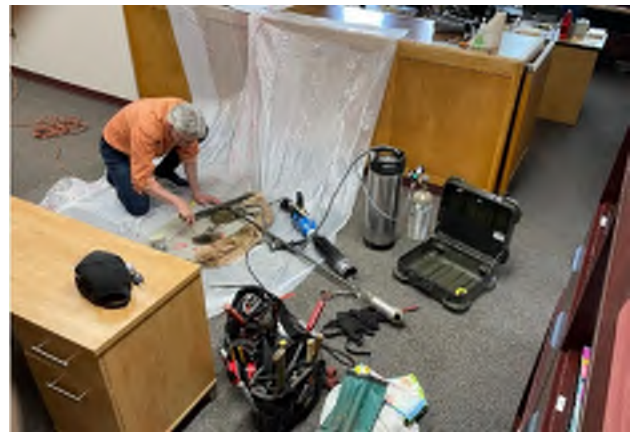
Once the areas of greatest deflection were identified, a second soils sample was taken on August 6th, 2021. This sample was extracted by cutting a second core through the slab and acquiring a soil sample using a hand auger as shown in the photos below. The soil profile was identical to the initial sample taken in May including large chunks of granite within the 4" zone extending below the bottom of the concrete slab. Based upon the findings of the second sample, TD&H assumes this soil profile is consistent around the other areas exhibiting significant deflection.

Second sample taken on August 6th, 2021 at a location of significant deflection.

3. Abandon the underground ducts and fill with CDF (Controlled Density Fill). CDF is a flowable, self-leveling, cementitious slurry consisting of a mixture of fine aggregate or filler, water, and cementitious material(s), which is used primarily as a backfill in lieu of compacted earth. This mixture is capable of filling voids in hard to reach places without the need for compaction in layers. New HVAC ducting would be provided above the ceiling to replace that being abandoned.

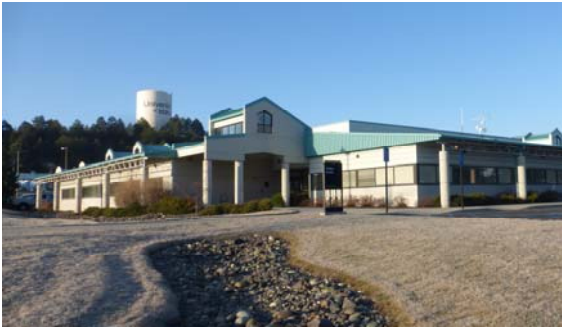
MAIN FACILITY SERVICES COMPLEX BUILDING

- All columns on both the north and east sides of the building show some degree of cracking ranging from minor surface cracks that would be considered normal to severe cracks and spalling that are up to a half inch wide. The most severe cracking is located at columns on the north side of the building that have downspouts cast inside them. It appears the downspouts are freezing and adding to the cracking of these columns.
- The columns have two chamfer features, that when the columns were cast, were to align with two chamfer features in the tilt-up wall panels and the top and bottom of the windows. The bottom column chamfer was cast higher than the one in the pre-cast panels and the bottom of windows. To correct this the chamfer was filled and a new chamfer ground into the columns. The filled in chamfers at each column are starting to crack and spall.

- Based on the construction documents there were two methods for installing the tilt-up wall panels. One was to install the panels directly on a footing the second was to construct a stem wall and install the panels on the stem wall which was the method that was used. Typically tilt-up panels are installed on shims so the panels can be aligned. Once aligned the panels are attached together and to the foundation. The shim space is then grouted with a non-shrink grout. At all locations where tilt-up panels were used the grout space between the panel and the stem wall is at or just above grade. Due to the inherent movement of the panels, cracks have formed in the grout joint allowing moisture to enter causing the grout to spall and in some instances causing spalling at the base of the wall panels. This is most evident along the side walls at the North loading dock.

- Roof overhangs along the north and east side of the building are constructed of exposed metal roof decking over exposed steel trusses. In several locations both the steel deck and roof trusses have rust starting to form and areas of peeling paint. In addition, metal door frames at the north loading dock and along the south side of the building are also developing areas of rust at the bottom of the frames.

- Wall paint, given its age, is generally in good condition with only a couple of areas where peeling is occurring at the parapets on the south side of the building. Where sidewalks and driving surfaces abut the walls the paint has been scraped and chipped along the bottom of the wall panels. This is taking place mainly where snow removal next to the walls occurs.
- Facia at one awning on the south side and the gutter along the roof overhang on the north side have been damaged most likely from larger vehicles running into them.

- Enclosed light wells and exhaust fans located on the east and north metal roofs were to originally have crickets installed on the up slope side. A flat piece of metal flashing was installed instead of the cricket which is allowing snow and water to back up against the light wells and exhaust fans causing leaking to occur.
- At the metal roofs snow bars are located along the eaves and approximately half way up the roof slopes. On the east metal roof a section of the upper snow bar has been torn off.

- Based on a visual examination of the single ply roofs and parapet caps it appears the roof system is in satisfactory condition. The top coating however is starting to thin over the scrim in a few locations due to age. Also the small single ply roof in the mechanical well at the roof access is billowed up. This is an indication moisture is trapped between the membrane and insulation or substrate below.

- Where columns are cracked and spalled remove loose concrete, clean reinforcing steel, patch back where material is removed and inject cracks with an epoxy adhesive.
- Cap off internal downspouts and install open face downspouts on the surface of the columns.
- Where chamfers are spalled remove spalled material and patch back with an epoxy based filler.
- At the base of the concrete wall panels, grind out grout as needed to install a backer rod and a polyurethane caulking.

- At locations where the concrete has deteriorate at the base of the concrete wall panels remove loose material clean and patch back.
- At roof overhangs sand blast rust areas at the steel trusses and areas where paint is peeling at roof deck.
- Sand blast rusted areas at door frames.
- Paint exterior walls, doors, door frames, and trusses.
- Replace the damaged gutter on the north side of the building and the damaged fascia on the south side of the building.
- Install crickets at the up slope side of all light wells and exhaust fan penetrations.
- Install snow bars where torn off at east metal roof.
- Within the next three to five years the single ply roofs should be replaced. The exception to this is the single ply roof at mechanical well should be replaced as soon as practical. This would allow inspection of the roof deck for deterioration.
